Hazardous Material Survey Report

ORION Project 020-0277

RE: Osborn Elementary School Demolition
225 Central Avenue
Leavenworth, Washington 98826

**Osborn Building Demolition
Cascade School District**

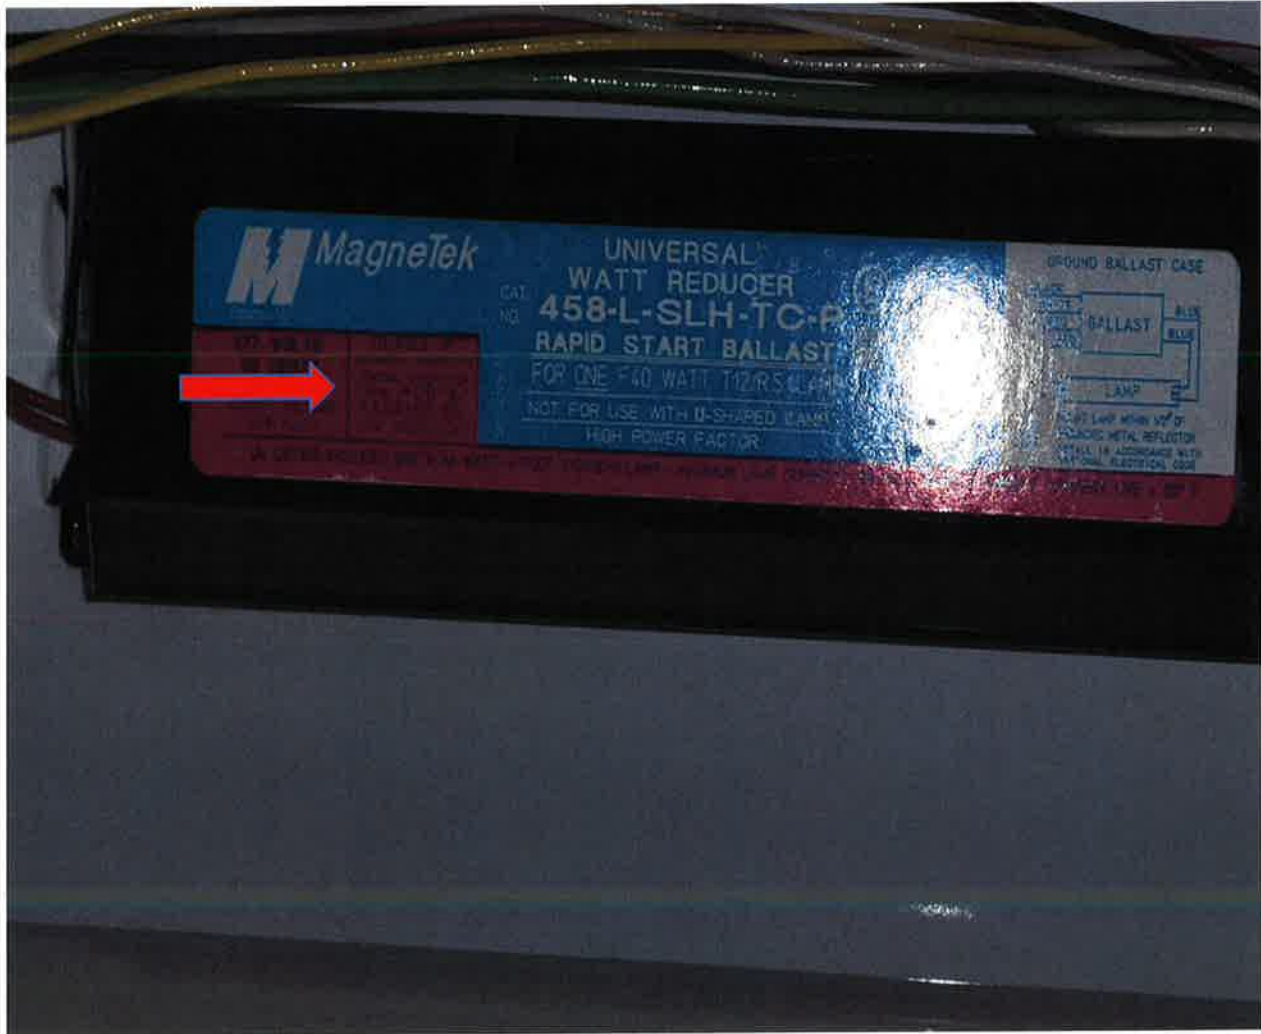
Fluorescent light ballasts were randomly examined throughout the buildings. The ballasts of these fixtures we identified were either electronic or ballasts were marked as “No PCB”

Ballast marked as “No PCB”

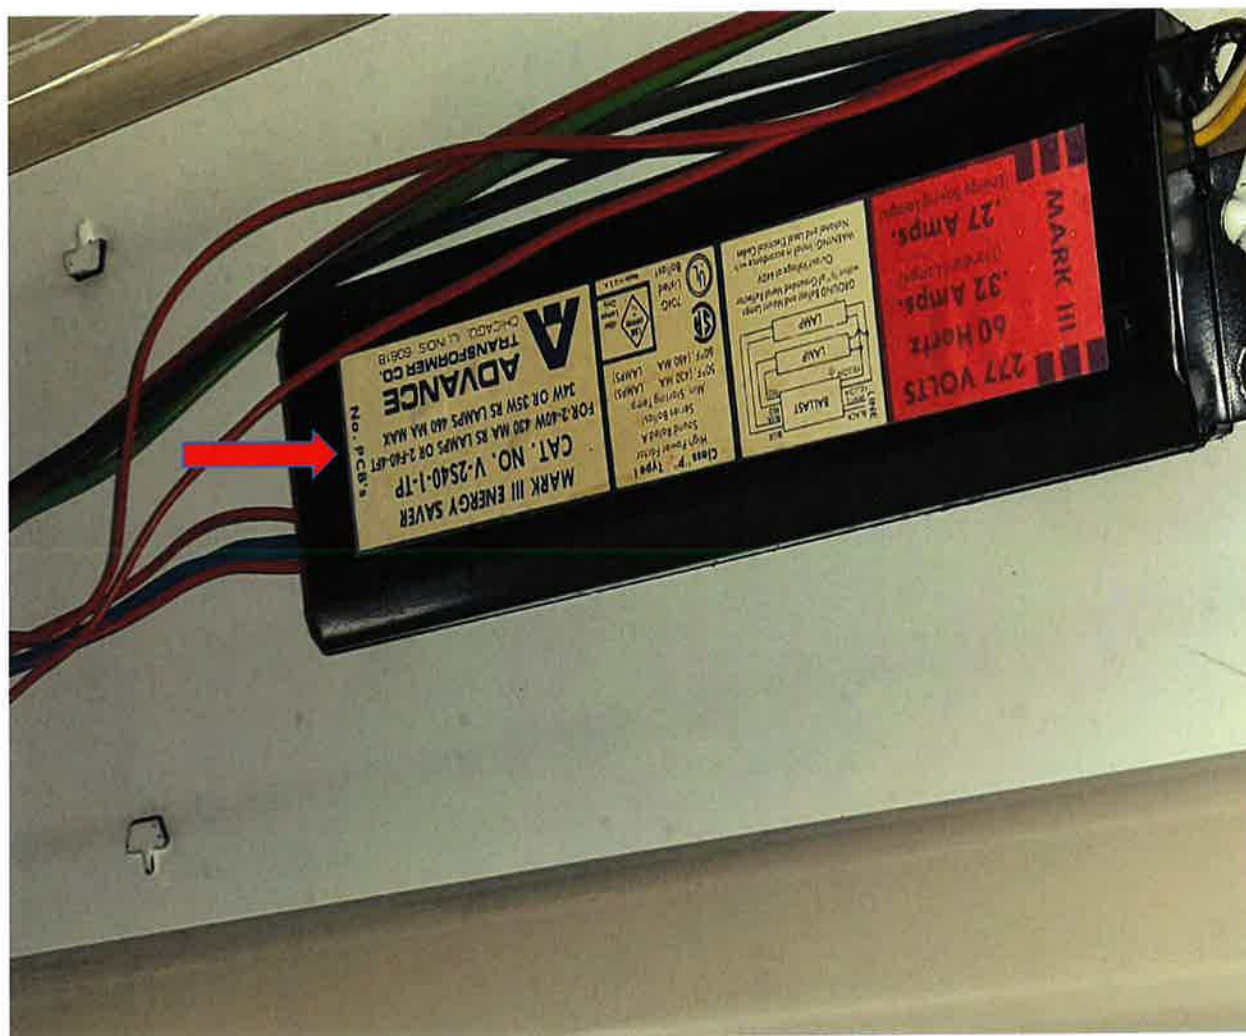
Ballast marked as "No PCB"
