Hazardous Material Survey Report

ORION Project 020-0277

RE: Osborn Elementary School Demolition
225 Central Avenue
Leavenworth, Washington 98826

**Osborn Building Demolition
Cascade School District**

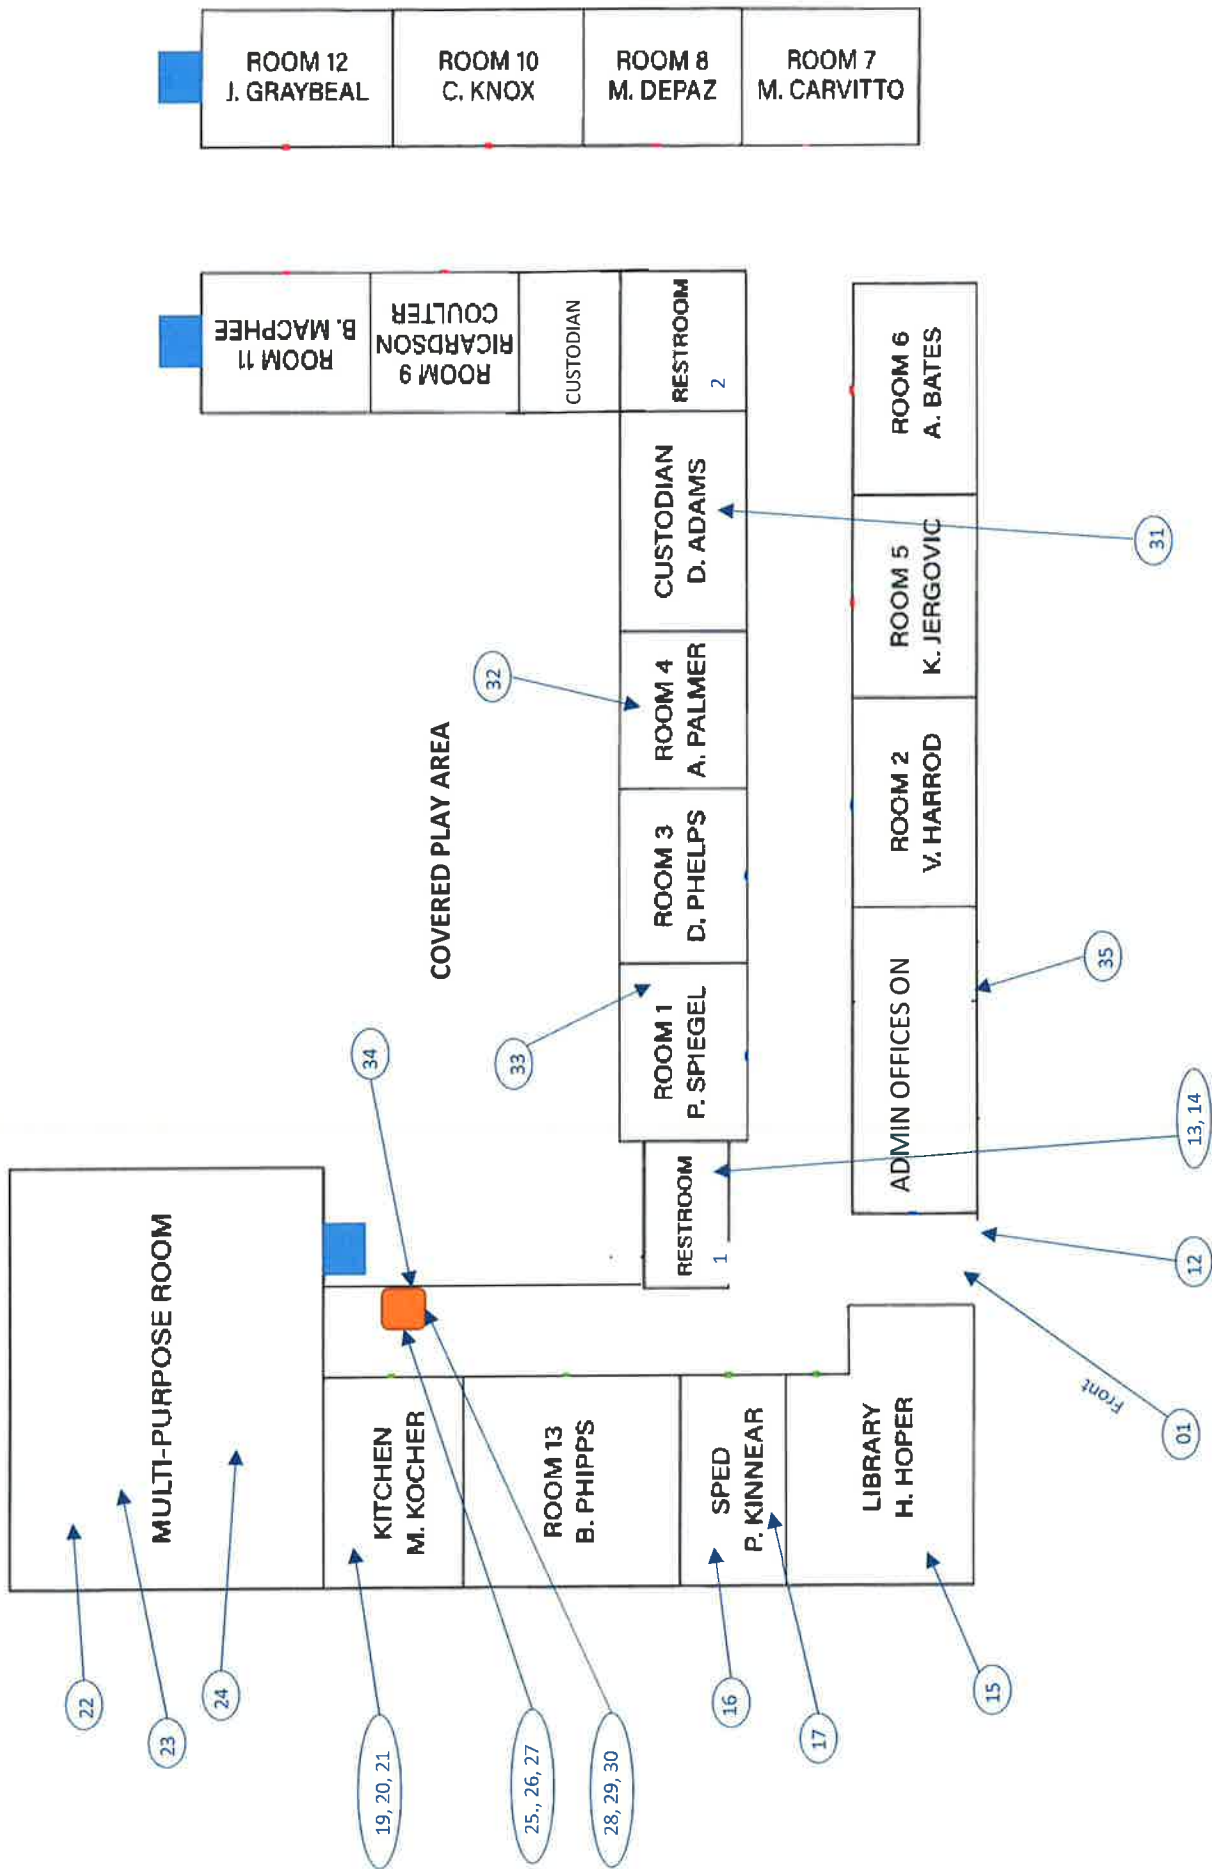
Sample Locations

Hatch - Exterior Tunnel Entrance

ADMIN	MAS1		CT1	VS1/VS2 (300 sf)	
	SNK1 X1	MISC1	WS1		
	CRT1 (160 sf)	CRT2 (25 sf)	INS1		
	CLK1	CLK2	CBM1	MISC1	
ENTRANCE	WS2	MISC1			
	MAS2				
	CBM1				
RESTROOM 1	CRT2	WS3			
GIRLS & BOYS	CRT3	WS1			
OUTSIDE ADMIN					
400 sf-total					
RESTROOM 2	CRT2	WS3			
ACROSS FROM ROOM 6	CRT3	WS1			
OUTSIDE ADMIN					
400 sf-total					
LIBRARY	MAS1	SNK1 X1	CBM1		
	CT1	WS1	MAS3		
ROOM 1	MAS1	SNK1 X1			
	MAS3	MISC1			
	CT1	WS1			
	CBM1	VS1/VS2 (300 sf)			
ROOM 2	MAS1	SNK1 X1			
	MAS3	MISC1			
	CT1	WS1			
	CBM1	VS1/VS2 (300 sf)			
ROOM 3	MAS1	SNK1 X1			
	MAS3	MISC1			
	CT1	WS1			
	CBM1	VS1/VS2 (300 sf)			
ROOM 4	MAS1	SNK1 X1			
	MAS3	MISC1			
	CT1	WS1			
	CBM1	VS2 (300 sf) - UNDER CARPET			
ROOM 5	MAS1	SNK1			
	MAS3	MISC1			
	CT1	WS1			
	CBM1	VS1/VS2 (300 sf)

ROOM 6	MAS1	SNK1 X1			
	MAS3	MISC1			
	CT1	WS1			
	CBM1	VS1/VS2 (300 sf)			
ROOM 7	MAS1	SNK1 X1			
	MAS3	MISC1			
	CT1	WS1			
	CBM1	VS1/VS2 (300 sf)			
ROOM 8	MAS1	SNK1 X1			
	MAS3	MISC1			
	CT1	WS1			
	CBM1	VS1/VS2 (300 sf)			
ROOM 9	MAS1	SNK1 X1			
	MAS3	MISC1			
	CT1	WS1			
	CBM1	VS1/VS2 (300 sf)			
ROOM 10	MAS1	SNK1 X1			
	MAS3	MISC1			
	CT1	WS1			
	CBM1	VS1/VS2 (300 sf)			
ROOM 11	MAS1	SNK1 X2			
	MAS3	MISC1			
	CT1	WS1			
	CBM1	VS1/VS2 (300 sf)			
ROOM 12	MAS1	SNK1 X1			
	MAS3	MISC1			
	CT1	WS1			
	CBM1	VS1/VS2 (300 sf)			
SPECED	MAS2	MISC1			
	MAS3	WS1			
	CT1	CBM2			
	CBM1				
ROOM 13	MAS1	SNK1 X1			
	MAS2	WS1			
	CT1	VS1/VS2 (300 sf)			
	CBM1
